Leaking at cover

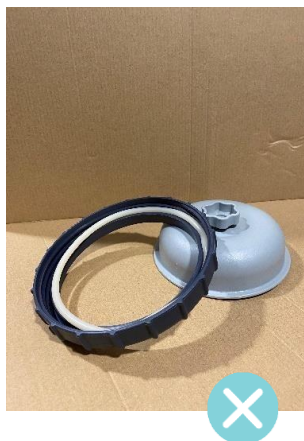
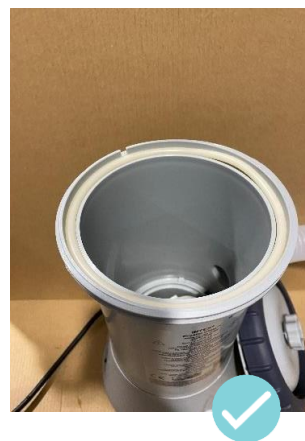
There are multiple possible causes for the leakage at the cover. The main reason is that the leakage is caused by the fact that the O-ring is not located under the lid, but in the screw ring. The O-ring should not be in the screw ring but in the housing under the cover. Due to its incorrect placement, the pump is not completely sealed off, which can result in leakage.

Below are two photos of both the correct and incorrect placement of the O-ring. Please check carefully whether it has been placed correctly, and if not, place it correctly using the step-by-step plan as mentioned above.

- Step 1:** Loosen the screw ring and remove the cover
- Step 2:** Remove the O-ring from the screw ring
(If it does not come loose, you can tap it gently on the ground to loosen the O-ring)
- Step 3:** Place the O-ring on the ledge on the inside of the filter housing
(where the lid used to be)
- Step 4:** Place the lid on top of the O-ring
- Step 5:** Tighten the screw ring
